# WRINKLED ROOF MEMBRANES: MATERIAL DIMENSIONAL STABILITY

SUMMARY OF THE PAPER BY JUN TATARA AND LORNE RICKETTS OF RDH BUILDING SCIENCE INC., PRESENTED AT THE 15TH CANADIAN CONFERENCE ON BUILDING SCIENCE AND TECHNOLOGY IN VANCOUVER (NOVEMBER 2017) AND AT THE RCI 2018 INTERNATIONAL CONVENTION IN HOUSTON (MARCH 2018).

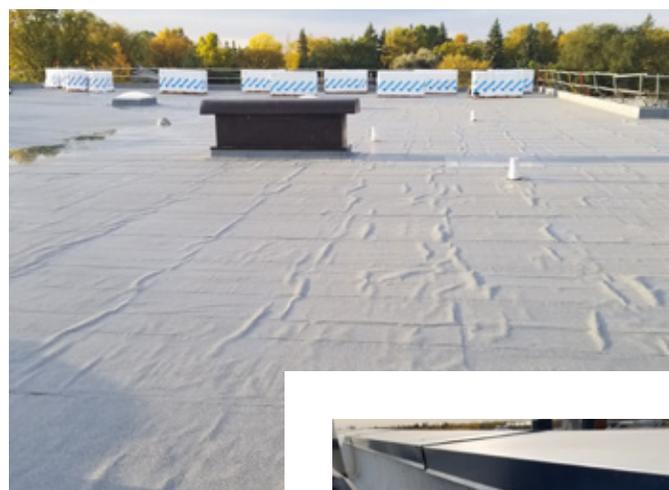
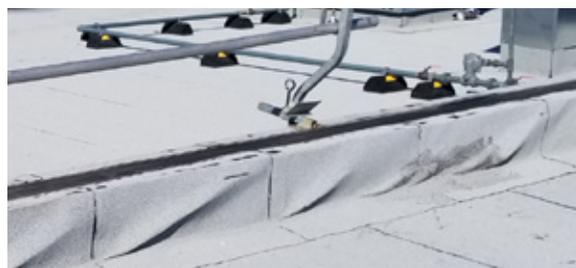
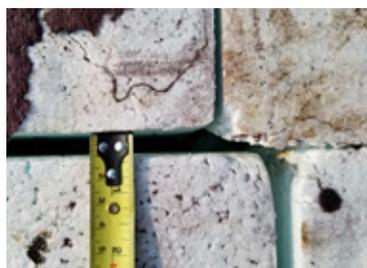
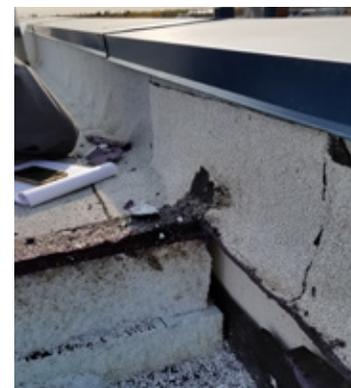
Field observations have recently noted problems with wrinkling of 2-ply styrene-butadiene-styrene (SBS) modified bituminous roof membranes. Wrinkling of roof membranes can be indicative of undue stress on the membrane and may lead to premature failures such as opening of laps, abrasion of the raised surface, and ponding of water.

Initial investigations of these issues found that wrinkling frequently correlates with the presence of expanded polystyrene insulation within the roof assembly, and when exploratory openings are made, gaps between insulation boards and between insulation boards and parapets are common. To investigate this issue further, a laboratory based research study was undertaken.

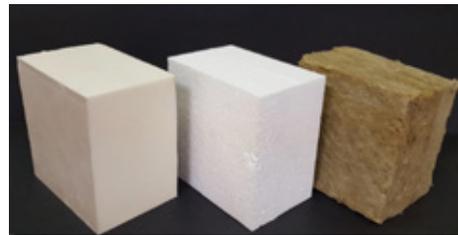
Based on the initial theory that dimensional stability of materials in the roof system may be a potential cause of the observed wrinkling, this initial phase of testing focused on whether it is possible to reproduce wrinkles in a laboratory test that are similar to those observed in the field. To do this, a range of 4' x 8' (1.2 m x 2.4 m) roof assembly test specimens were constructed with varying components so that the impact of each could be assessed. These included:

- Membrane reinforcement (polyester and composite)
- Cover boards (slip sheet (no board), asphaltic, and fiberboard)
- Insulation type (mineral wool (MW), expanded polystyrene (EPS), and polyisocyanurate (ISO)), and
- Attachment methods (mechanically fastened, ribbon adhered, and mopped)

These roof specimens were placed into a climate chamber which was used to uniformly expose them to hot temperatures up to approximately 90°C (194°F) and cold temperatures down to approximately -15°C (5°F). These temperatures were intentionally selected as extreme so as to simulate a worst-case scenario and accelerate the potential impacts of experimental exposure, thus verifying initial feasibility of the methodology to replicate wrinkles from this mechanism and rule out parameters which do not cause wrinkling under these conditions.

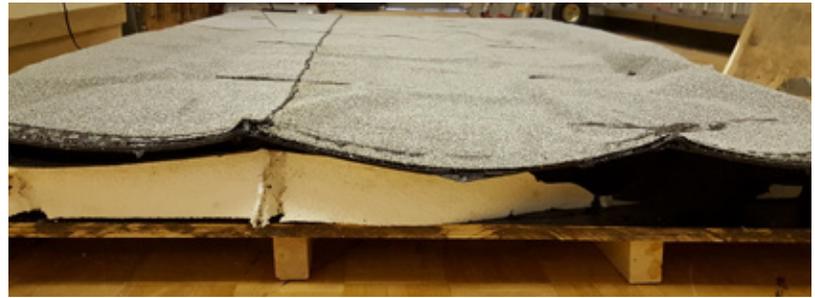
EPS Roof Specimen after Heating

Testing of the various combinations of roof assembly components found that wrinkles were only created during the laboratory testing when EPS insulation was included in the roof specimen (page 3, top right). It was also noted that while all of the specimens experienced some change in the size of the gap between insulation boards during testing, the roof specimens with EPS experienced significantly larger changes in gap size, in particular at high temperatures, and that these changes were permanent with the EPS not returning to its original condition upon completion of the testing when returned to room temperature (page 3, bottom).

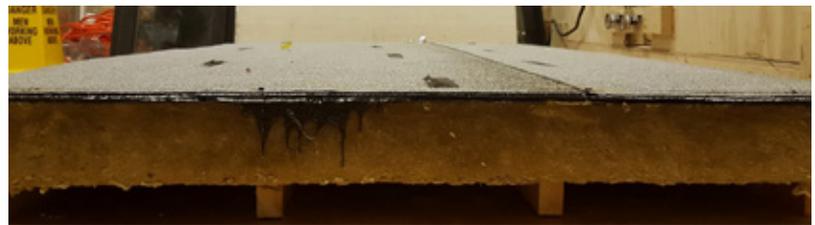
Mineral Wool Roof Specimen after Heating

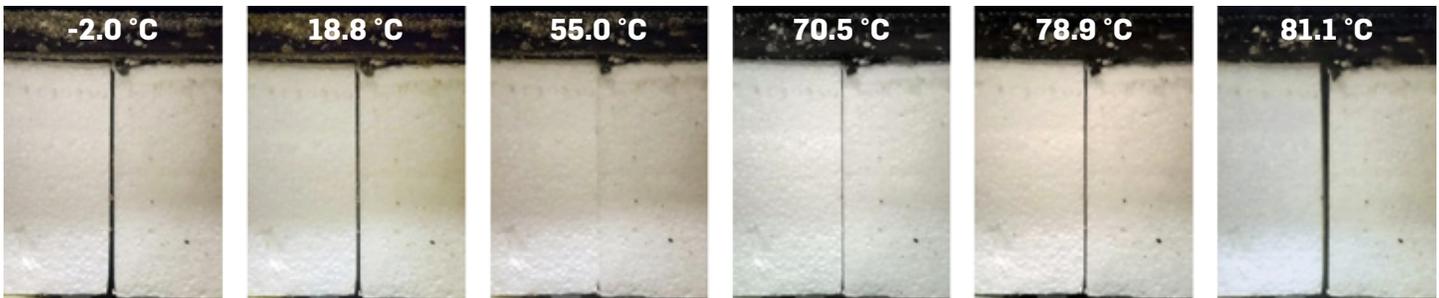
## EPS Insulation

Photographs of the gap between insulation boards during exposure to uniform heating and cooling of the roof specimens.

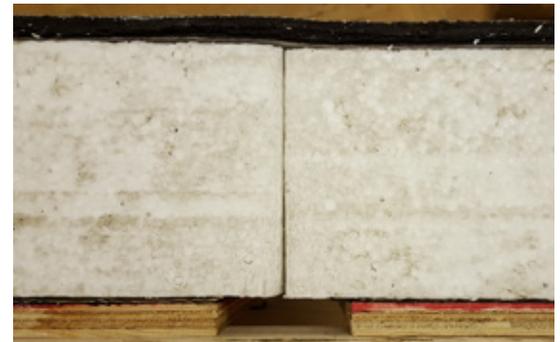
Before Heating

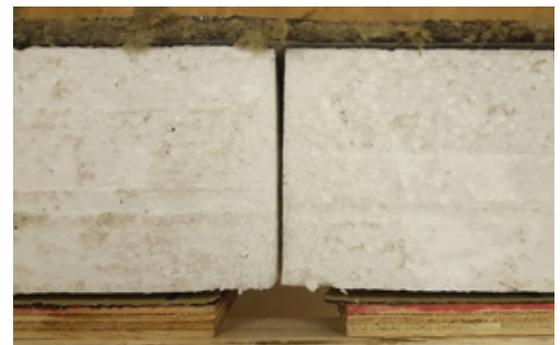
After Heating
